Transport
Canada

TP 6980E

Issue 4/2005

Canadian Aviation Service Difficulty Reports

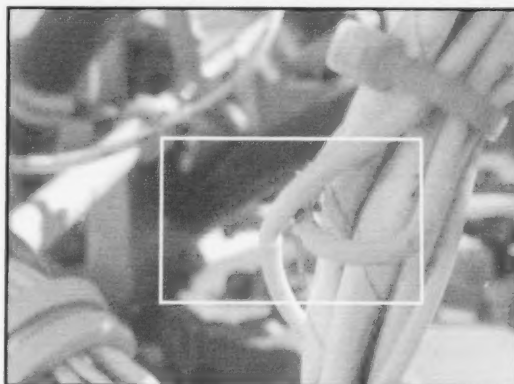
**CESSNA 650**

Flap Flex Shaft Retainer Missing

Retainer Missing

While performing a visual inspection, the right flap flex shaft retainer was discovered to be missing and possibly broken off.
